Manhole Inspection Summary

Manhole # S13EE_005MH

Location Address: **2819 PRESSMAN ST**

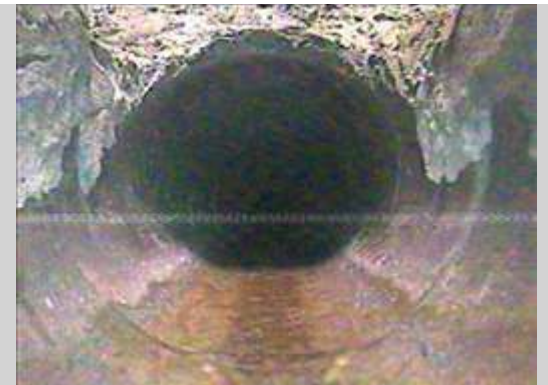
6 O'Clock Inflow

6 in. Circular Gravity Sewer
Pipe In @ 6 O'Clock

Pipe Height: (in.) Direct
Pipe Material: **Clay** ☐ Pipe Lined
Invert Depth: **5.90** (ft.) Flow Characteristics: **Fast**
Deposits: ☒ None ☐ Mud ☐ Sludge ☐ Debris ☐ Grease
Silt Depth: (in.) Deposits Extent:
Infiltration: **None** Pipe Seal Cond: **Sound**
